EDON fiberglass

EC-120Y 28" DIA. TUSCAN COLUMN COVER W/ENTASIS

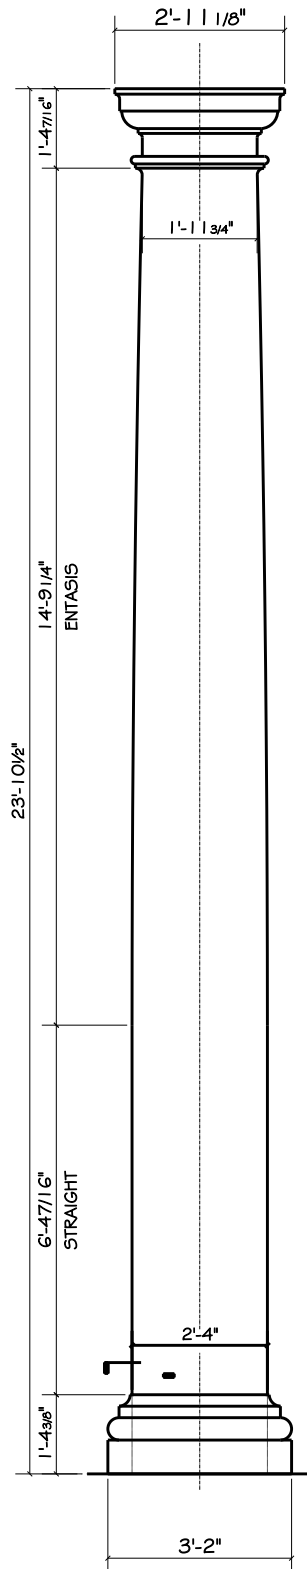
COLUMNS AND BASES TO BE ASSEMBLED AND PAINTED IN THE FIELD

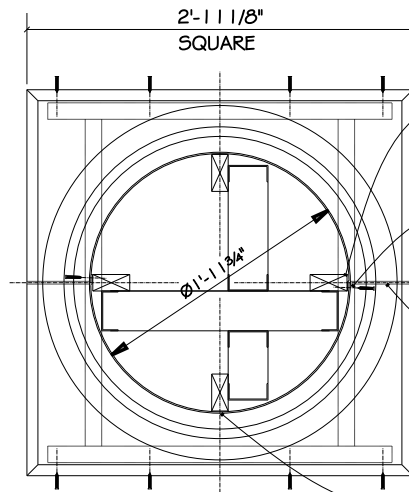
CAPITAL FROM BELOW

RIP PRESSURE TREATED 2x6 TO CONFORM TO INSIDE PROFILE OF LAP JOINT

STAINLESS STEEL FLATHEAD SCREWS COUNTERSUNK AND PATCHED

BUTT FLANGE ASSEMBLY JOINT @ CAPITAL (APPLY ADHESIVE / SEALANT TO FLANGES PRIOR TO ASSEMBLY)

USE CONSTRUCTION ADHESIVE TO FASTEN COLUMN TO BLOCKING AT THIS LOCATION

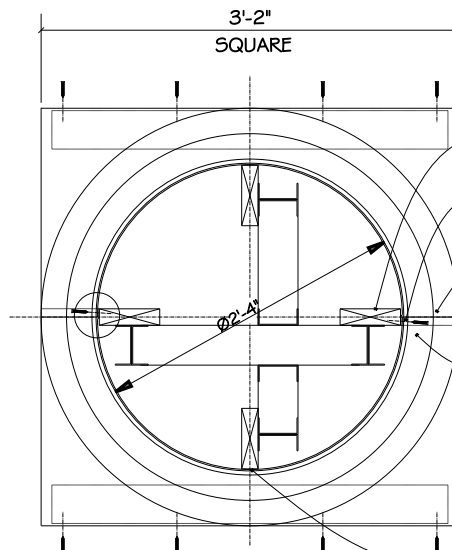
PLAN OF BASE

RIP PRESSURE TREATED 2x6 TO CONFORM TO INSIDE PROFILE OF LAP JOINT

STAINLESS STEEL FLATHEAD SCREWS COUNTERSUNK AND PATCHED

COLUMN AND BASE SEAMS TO BE FINISHED IN FIELD BY INSTALLER

USE CONSTRUCTION ADHESIVE TO FASTEN COLUMN TO BLOCKING AT THIS LOCATION
